# ENVIRONMENTAL ASSESSMENT REPORT

## LINEAGE INDUSTRIAL FIRE 2026

Christopher Dena Elementary School  
1314 South Dacotah Street  
Los Angeles, California

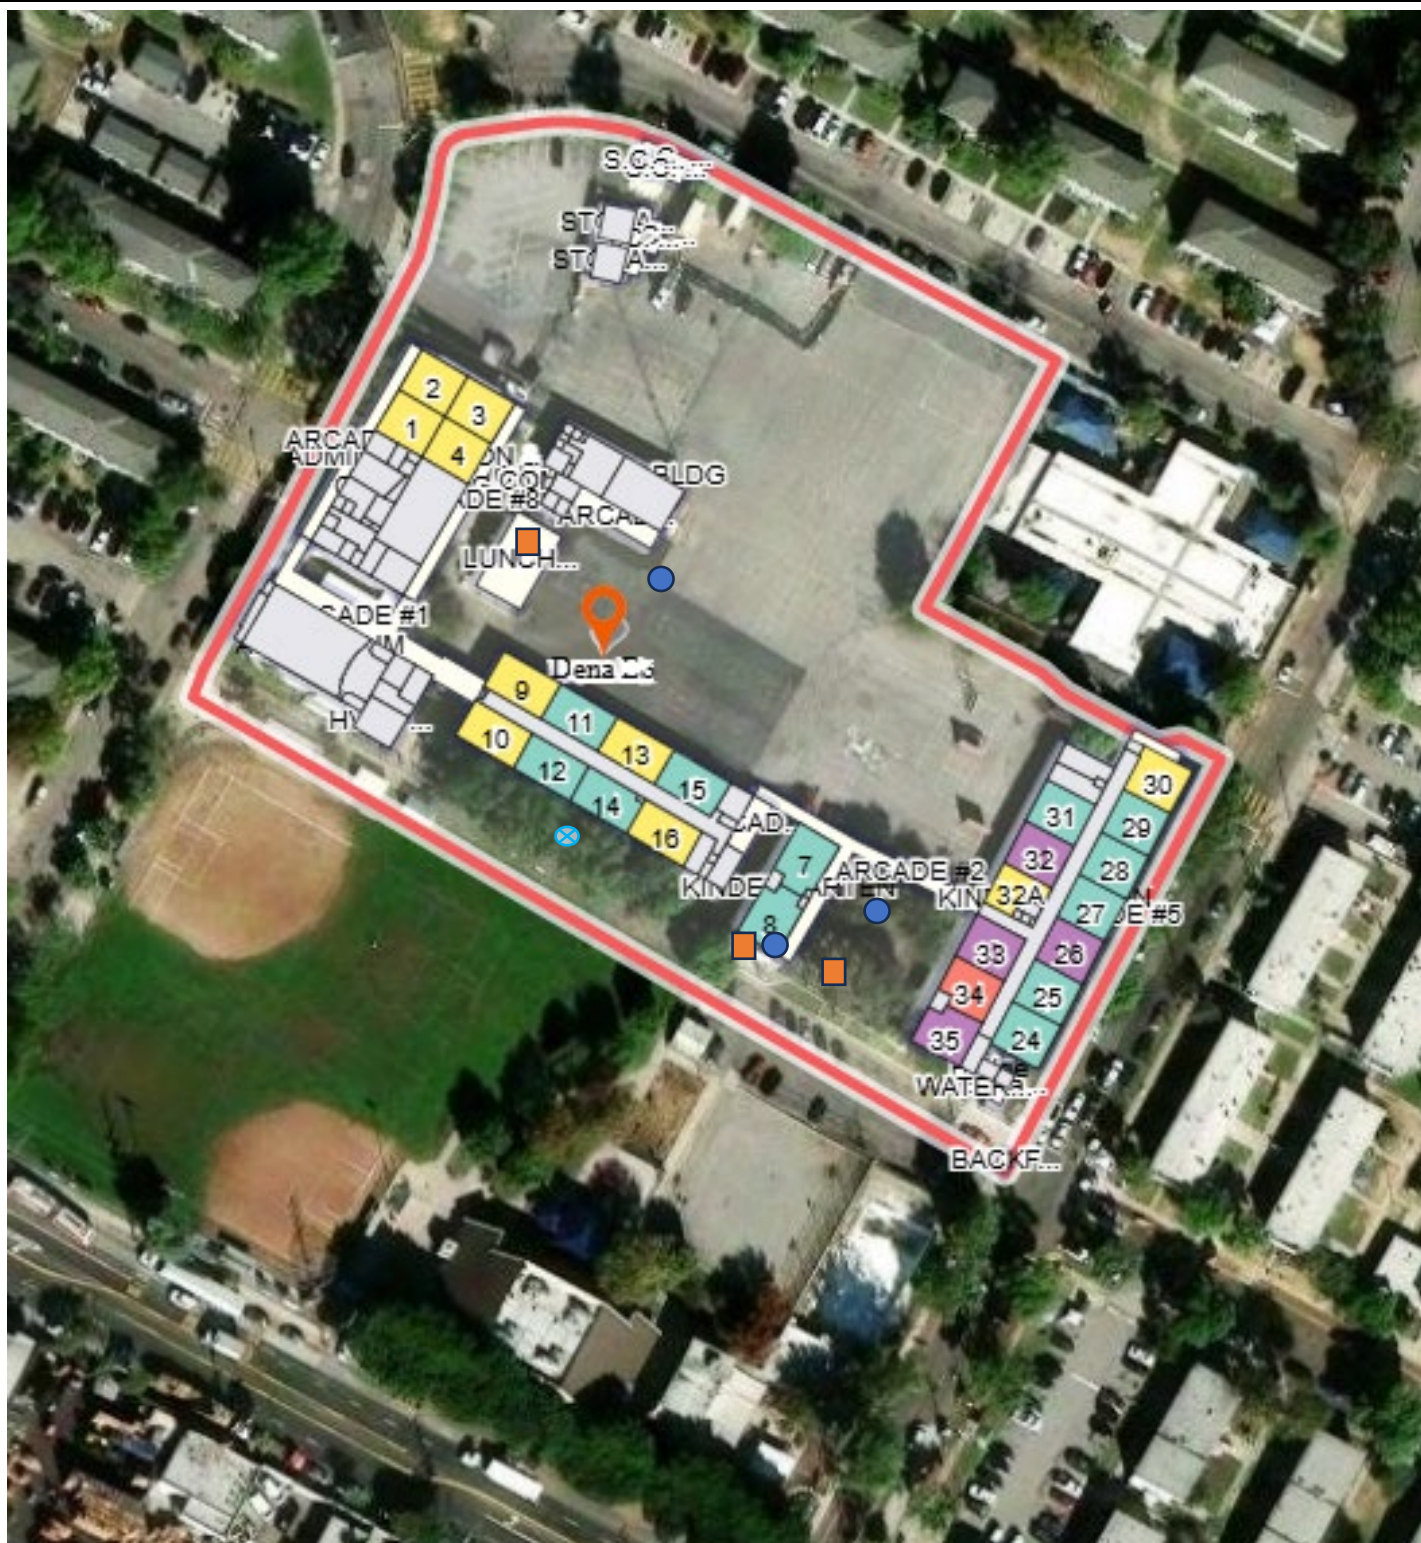
Wipe samples were collected from common high-touch surfaces and both air and dust wipe samples were collected from representative indoor and outdoor spaces. A soil sample was collected from an unpaved potential deposition zone. Sample locations for Dena ES are provided in the table below and a sampling location map is provided as Figure 2.

- Air sample location
- Dust wipe sample location
- ⊗ Soil sample location
