# ENVIRONMENTAL ASSESSMENT REPORT

## LINEAGE INDUSTRIAL FIRE 2026

Dacotah Early Education Center  
3142 Lydia Drive  
Los Angeles, California 90023

Los Angeles Unified School District  
Office of Environmental Health and Safety

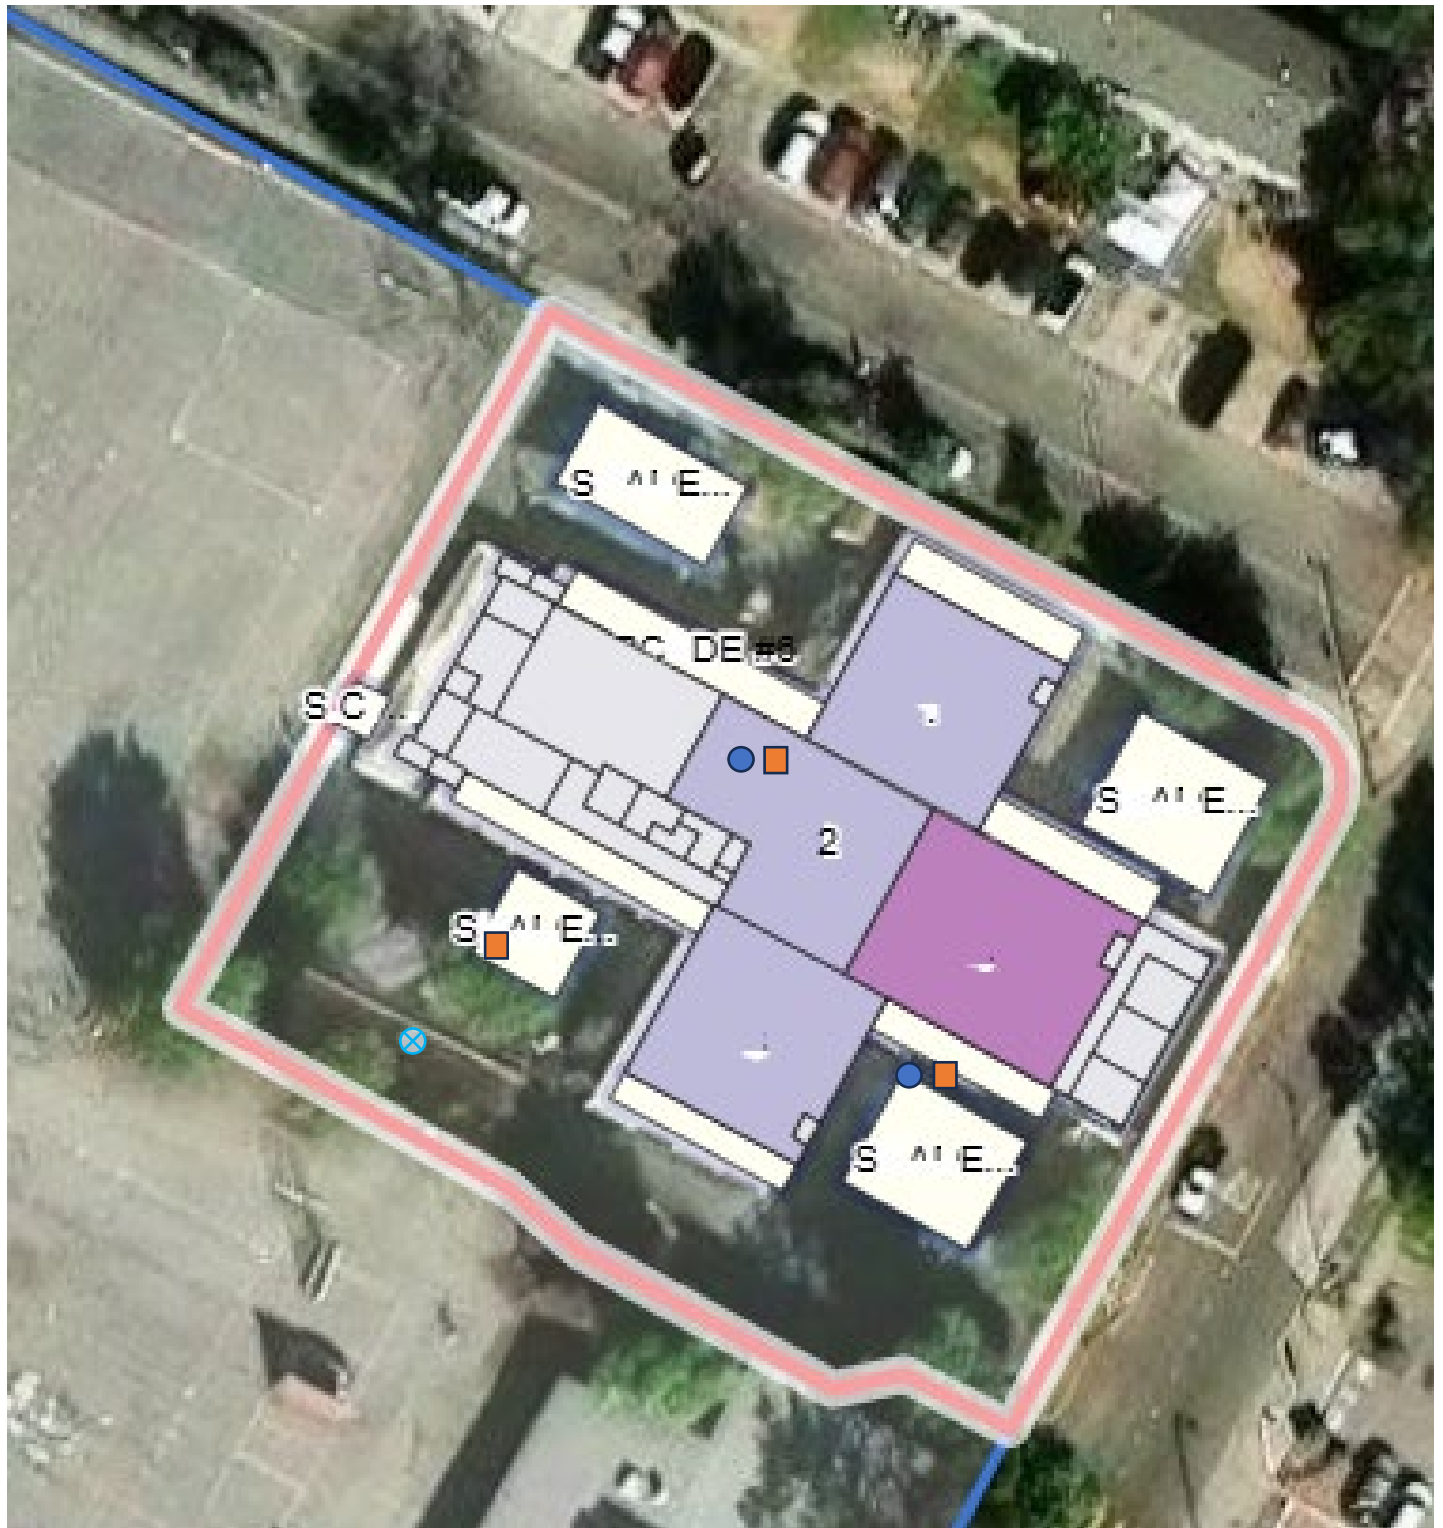
Wipe samples were collected from common high-touch surfaces and both air and dust wipe samples were collected from representative indoor and outdoor spaces. A soil sample was collected from an unpaved potential deposition zone. Sample locations for Dacotah EEC are provided in the table below and a sampling location map is provided as Figure 2.

Sample Locations: Dacotah EEC

| <i>Sample type</i> | <i>Indoor / Outdoor</i> | <i>Sample Location(s)</i> |
| Air | Indoor | Room 2 |
| | Outdoor | Playground (Shade Structure #4) |
| Dust wipe | Indoor | Student desk – Room 3 |
| | Outdoor | Playground – Shade Structure #4 |

| | Outdoor | Table – adjacent to garden bed (west campus) |
| Soil | Outdoor | Planter – west campus |
