# ENVIRONMENTAL ASSESSMENT REPORT

## LINEAGE INDUSTRIAL FIRE 2026

Eastman Avenue Early Education Center  
1266 South Gage Avenue  
Los Angeles, California 90023

Los Angeles Unified School District  
Office of Environmental Health and Safety

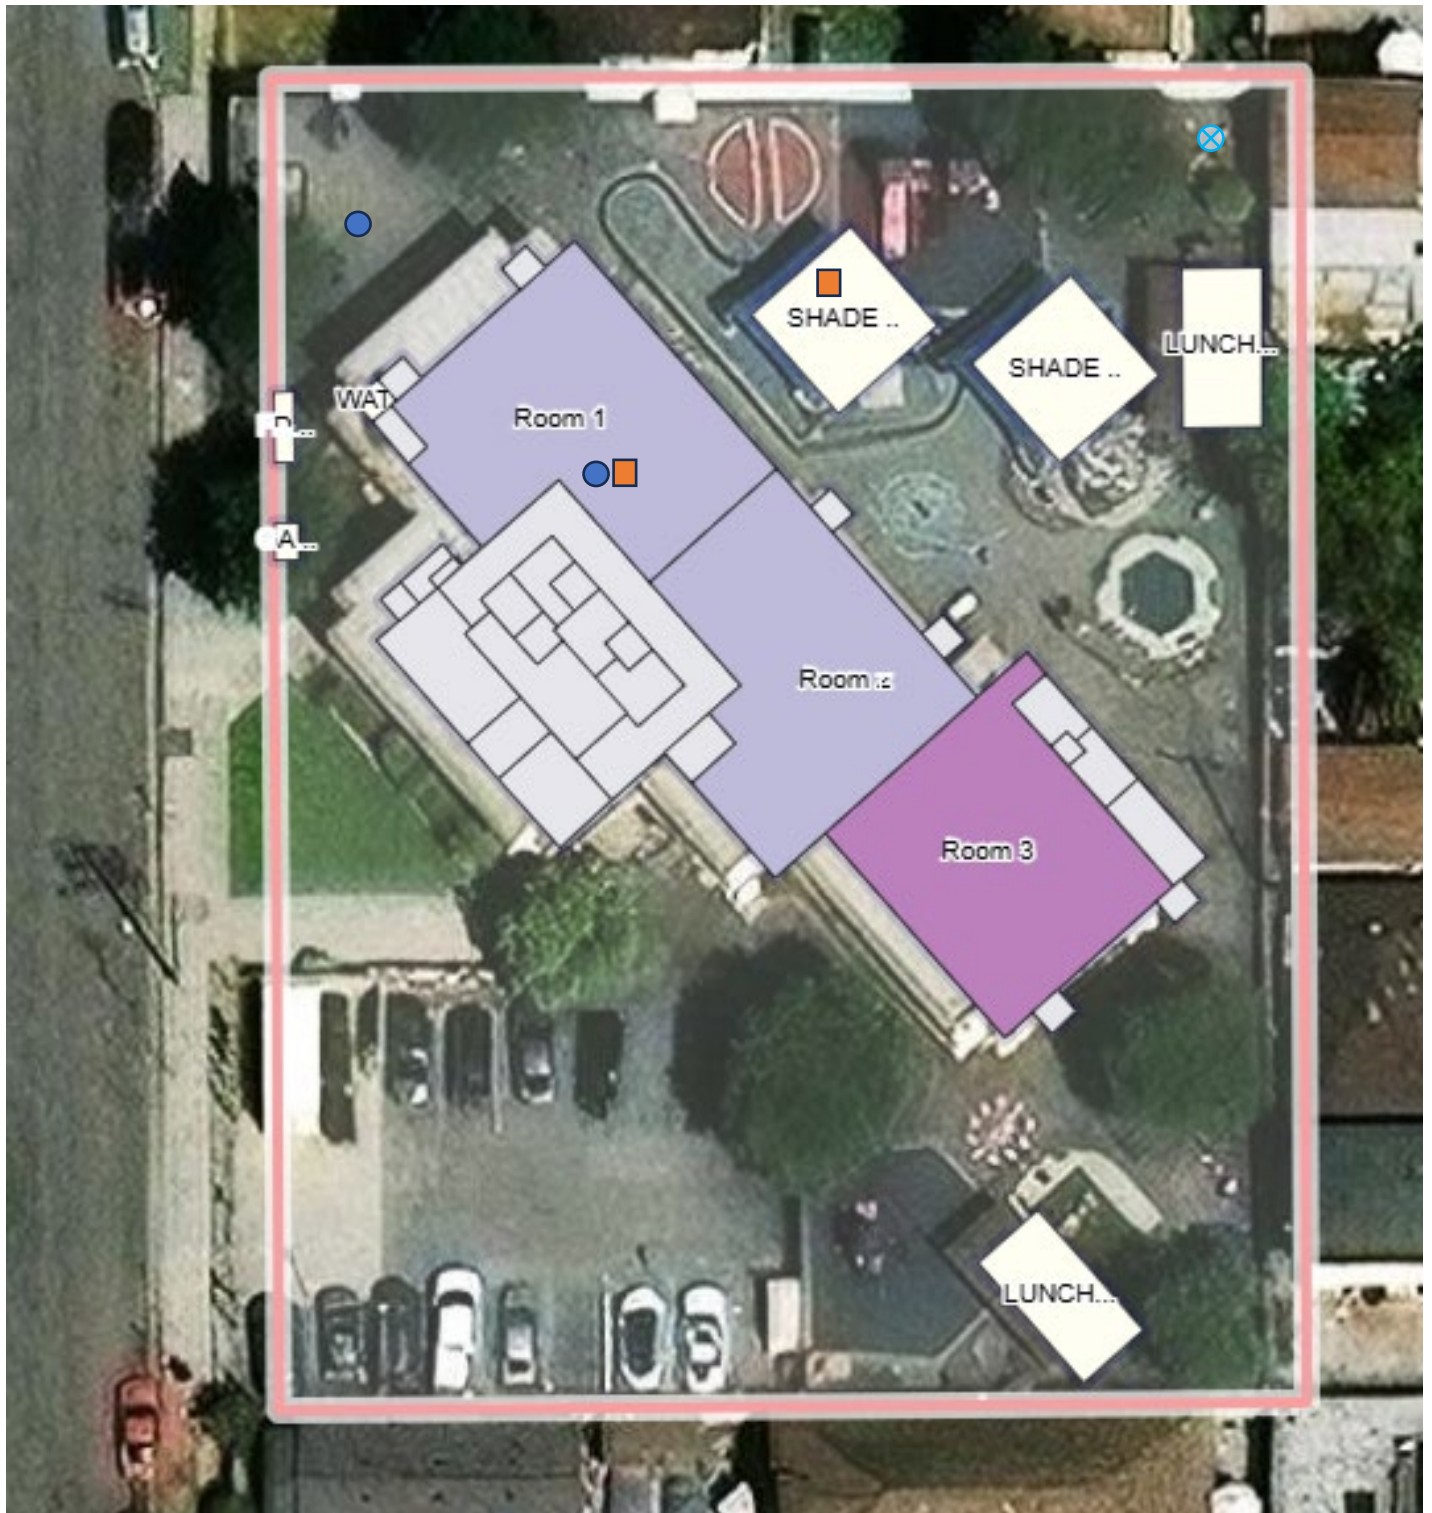
Sample locations for Eastman EEC are provided in the table below and a sampling location map is provided as Figure 2.

Sample Locations: Eastman EEC
